# Inspection Report

## Sample Report

**Property Address:**  
3418 Somewhere In.  
Weddington NC 28105

**Prevention Home Inspection LLC**

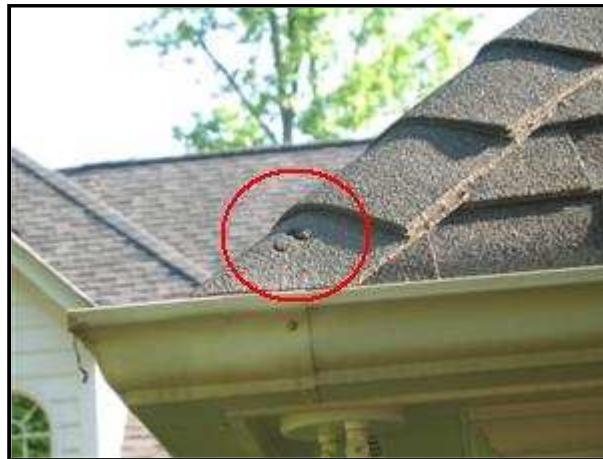
1.0 Picture 1

(1) Small hole in shingle on lower left side of garage. May be a possible point of water penetration. I recommend sealing with small amount of roof sealant.

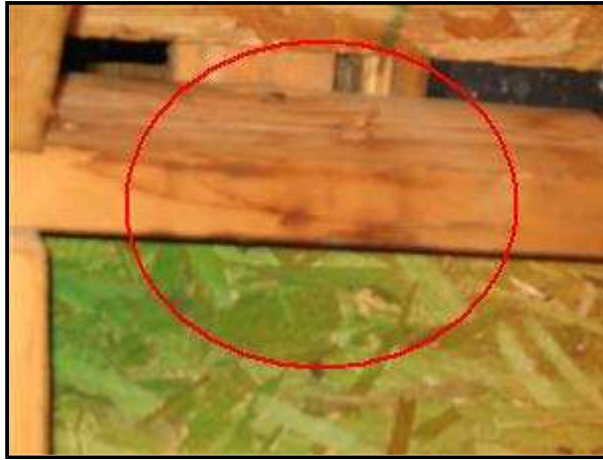
1.2 Picture 1

There is an area of concern below copula on garage. Water stain is visible on underside of rafter. I am unable to determine if this is an old, new, or one time event. No damage has occurred. I recommend further monitoring.

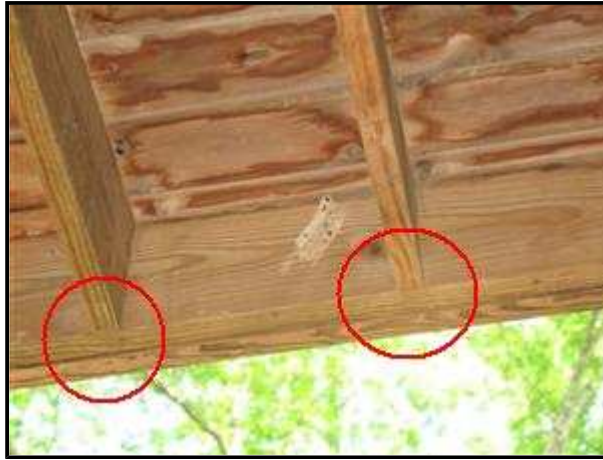
2.3 Picture 1 Joist Support

(1) Left screened deck at back of house has floor joists that are not properly supported. Recommend notching onto ledger board or (Picture 1) installing joist hangers by a qualified individual.

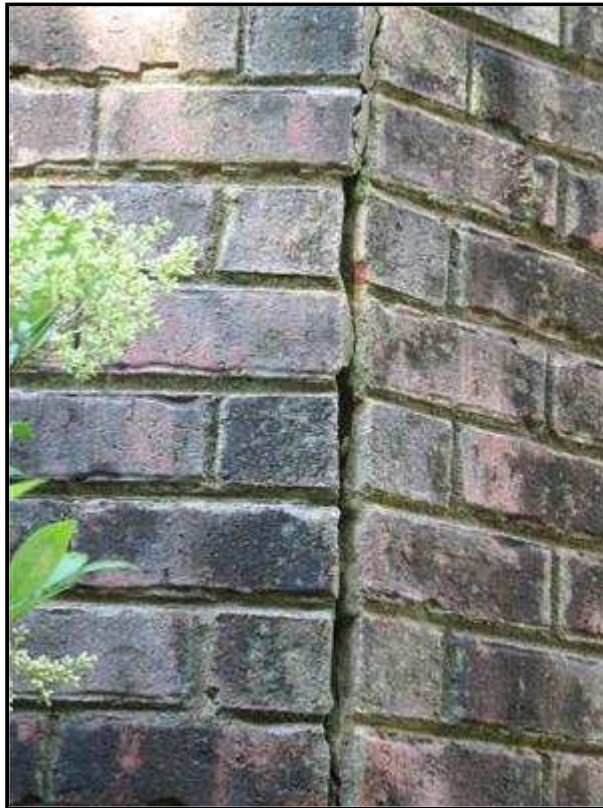
2.3 Picture 2 brick opening

(2) The right rear corner of on the exposed patio at the right side of house has a opening between bricks. I recommend a mason pointing up with mortar and further monitoring for continuing movement.(Picture 2)

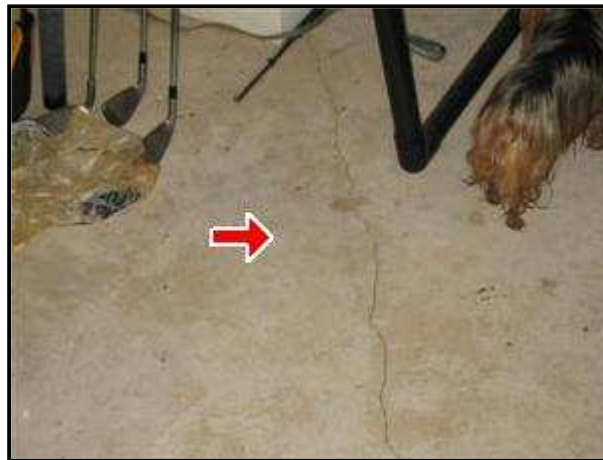
3.2 Picture 1

The concrete floor of garage is cracked in areas. These cracks do not appear significant and seem typical. I suggest continuing to monitor these over long term.

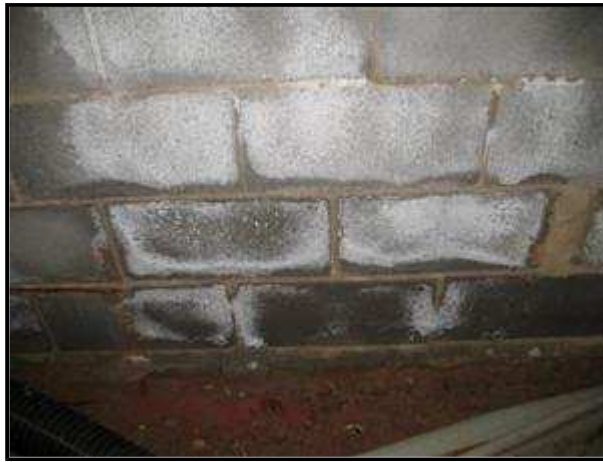
5.0 Picture 1 Efflorescence

(1) White efflorescence (powder substance) on block wall indicates moisture is in contact with the masonry. (Picture 1) This does not necessarily indicate that intrusion will occur. I recommend checking the gutters and the downspout drain lines for proper operation. Efflorescence is found on many homes without water intrusion occurring inside the home. But, it should alert you to the possibility that future steps may be needed.

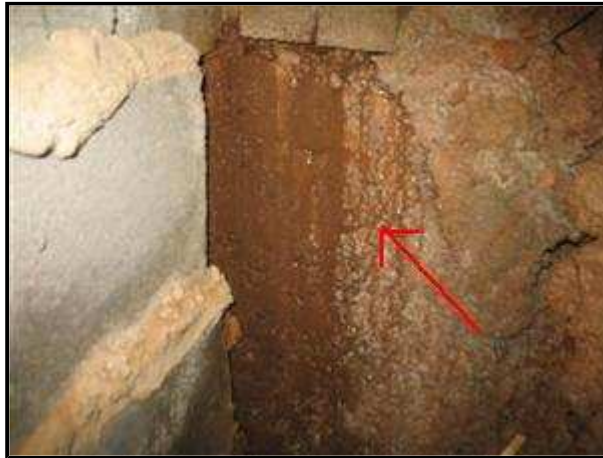
5.0 Picture 2 water intrusion

(2) Active water penetration into crawlspace at front foundation wall to the left of front entrance .(Picture 2) Water intrusion can cause deterioration and excessive moisture on building components if not corrected.This area of water intrusion corresponds with an improperly diverted downspout on the exterior. Landscape grading and roof drainage is a good first step in solving moisture problems. Recommend further investigation by a qualified professional.

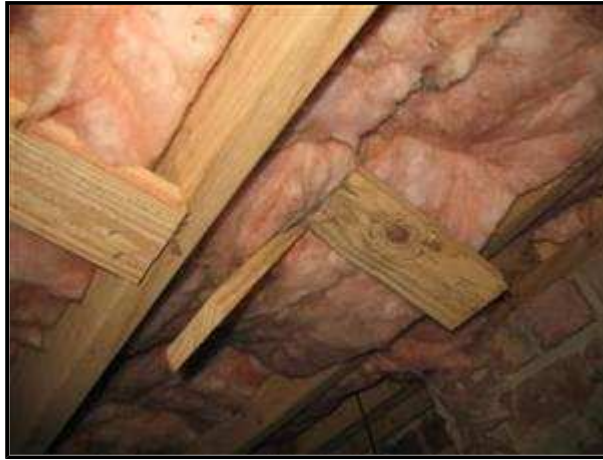
5.3 Picture 1 Bridging not nailed

Bridging not nailed in some areas at front right crawlspace below kitchen.recommend nailing for increased stability

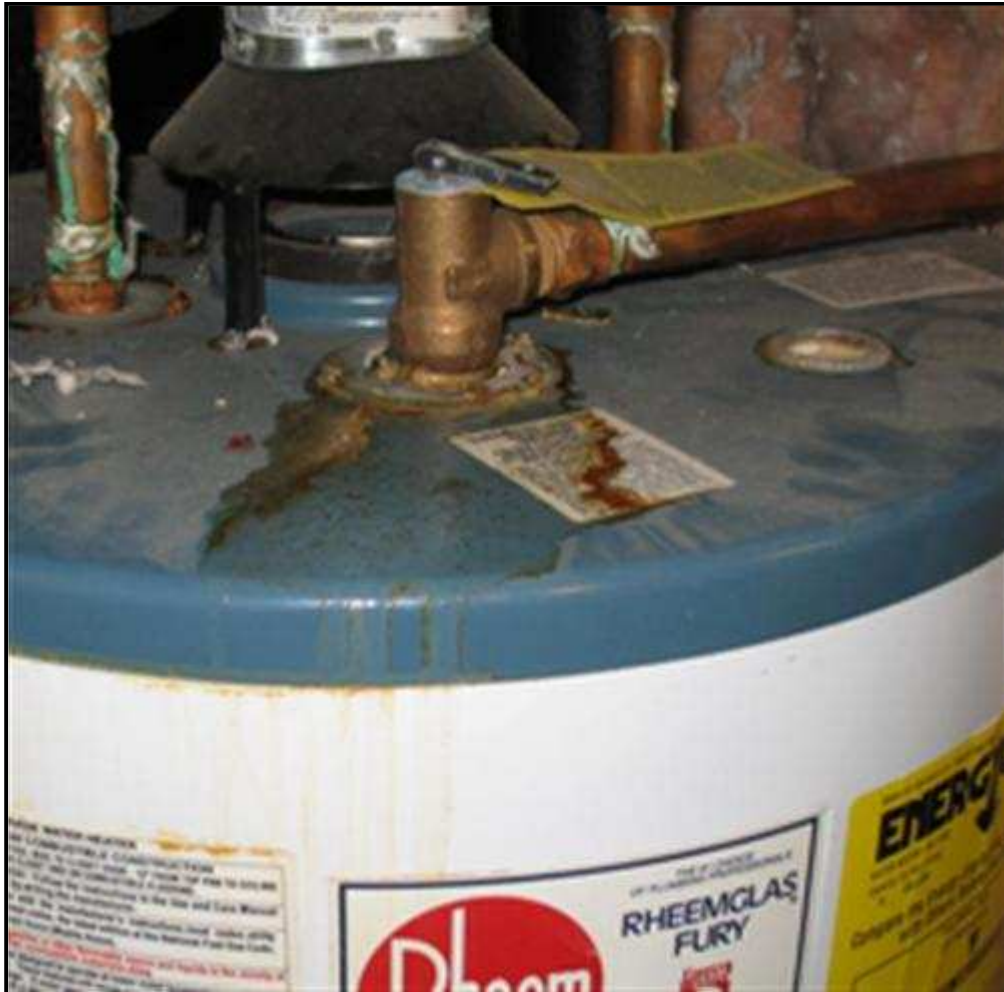
6.2 Picture 1

(2) The water heater located in attic access off second floor office appears to be leaking at top of unit. A replacement is needed. I recommend a qualified professional inspect further and repair as necessary.

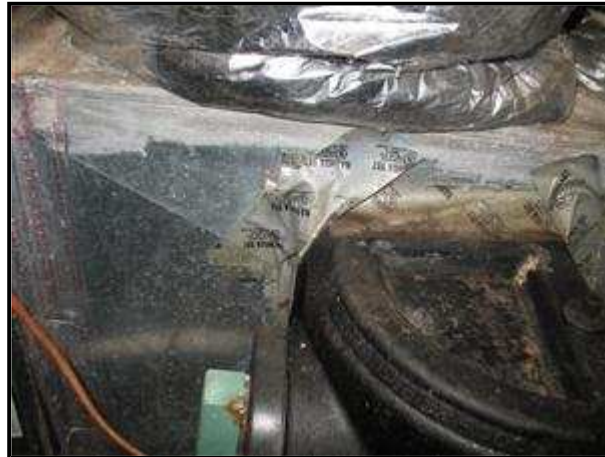
8.3 Picture 1 loose tape

(1) The humidifier connection to basement furnace is loose.(Picture 1)

(2) These conditions can adversely affect overall system efficiency. I recommend a qualified professional to assess and make needed repairs.

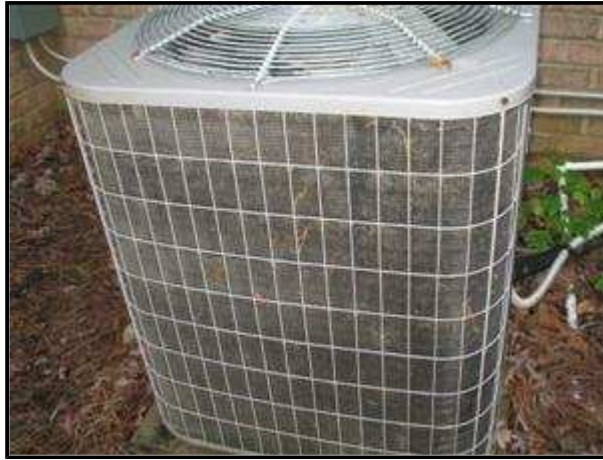
8.8 Picture 1 dirty coils

(3) Oxidation and dirt and debris has accumulated on outside AC unit. Dirty coils can affect overall system efficiency.Recommend cleaning coils by qualified individual.(Picture 1)

(4) These conditions can adversely affect overall system efficiency. I recommend a qualified professional to assess and make needed repairs.

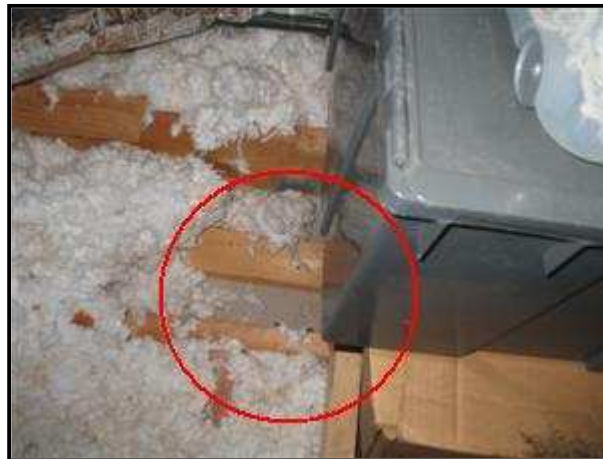
9.0 Picture 1

Fiberglass (loose-fill) insulation is Missing or pushed back in attic. even relatively small areas of missing insulation can result in considerable heat loss. A qualified person should repair or replace as needed.

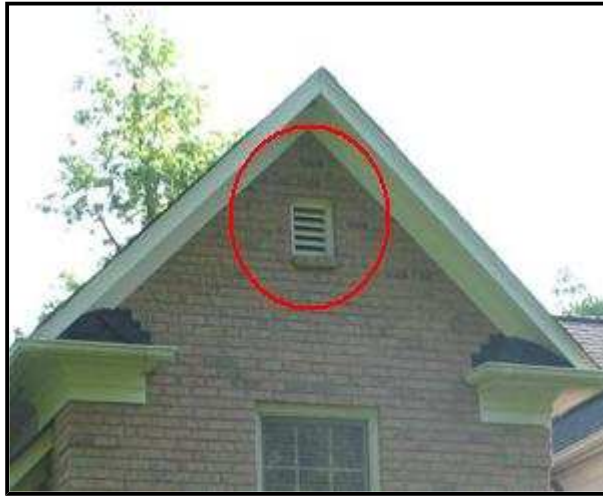
9.3 Picture 1

Vent Screening is missing on front of home (attic) allowing insects and/or animals entry. I recommend screening to be replaced.

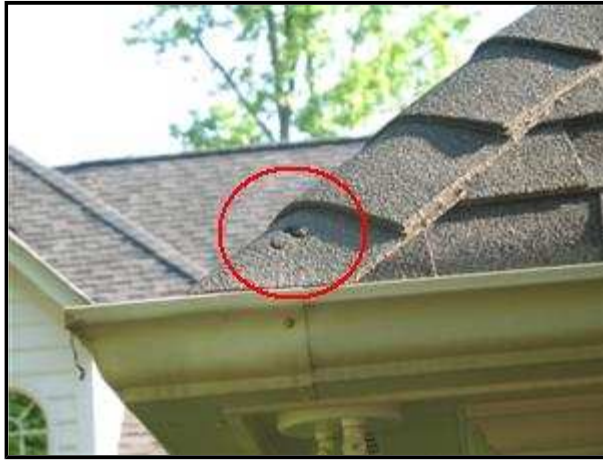
Item 1 - Picture 1

(1) Small hole in shingle on lower left side of garage. May be a possible point of water penetration. I recommend sealing with small amount of roof sealant.

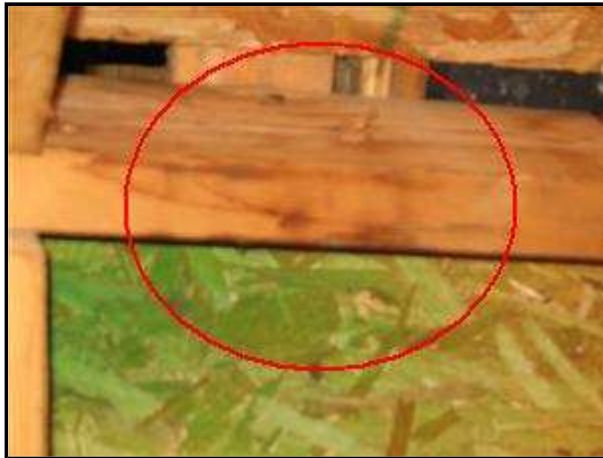
Item 2 - Picture 1

There is an area of concern below copula on garage. Water stain is visible on underside of rafter. I am unable to determine if this is an old, new, or one time event. No damage has occurred. I recommend further monitoring.

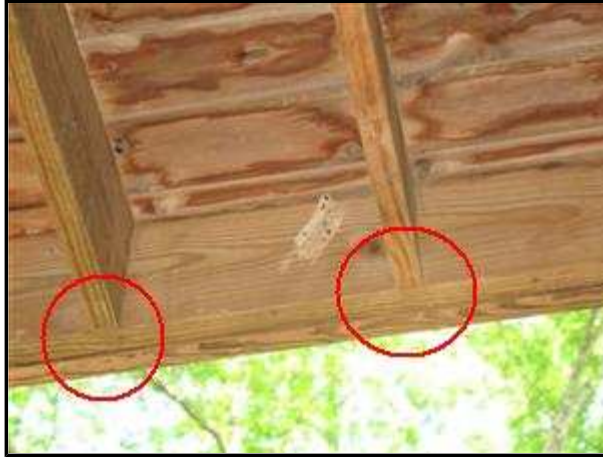
Item 4 - Picture 1 Joist Support

(1) Left screened deck at back of house has floor joists that are not properly supported. Recommend notching onto ledger board or (Picture 1) installing joist hangers by a qualified individual.

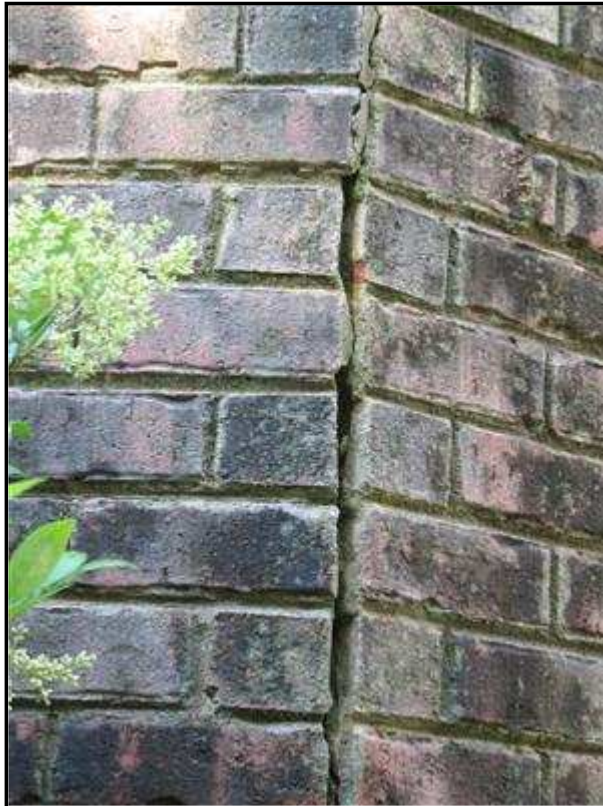
Item 5 - Picture 1 brick opening

(2) The right rear corner of on the exposed patio at the right side of house has a opening between bricks. I recommend a mason pointing up with mortar and further monitoring for continuing movement. (Picture 2)

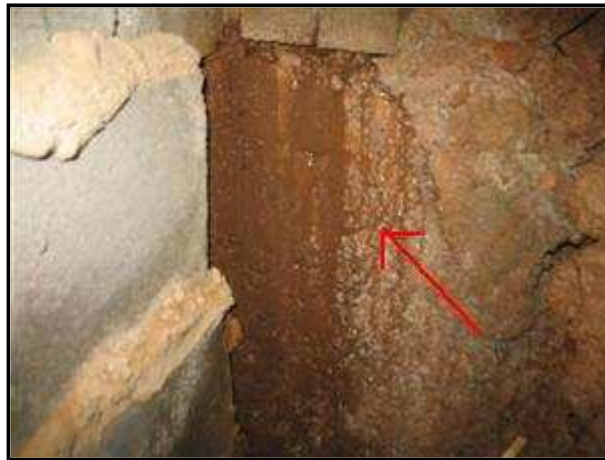
Item 6 - Picture 1 water intrusion

(2) Active water penetration into crawlspace at front foundation wall to the left of front entrance .(Picture 2) Water intrusion can cause deterioration and excessive moisture on building components if not corrected.This area of water intrusion corresponds with an improperly diverted downspout on the exterior. Landscape grading and roof drainage is a good first step in solving moisture problems. Recommend further investigation by a qualified professional.

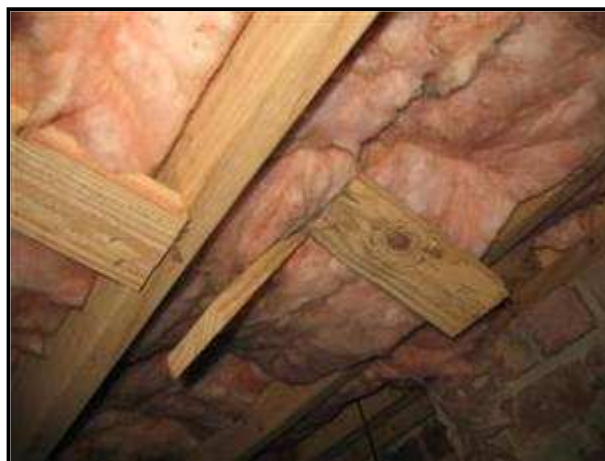
Item 7 - Picture 1 Bridging not nailed

Bridging not nailed in some areas at front right crawlspace below kitchen.recommend nailing for increased stability

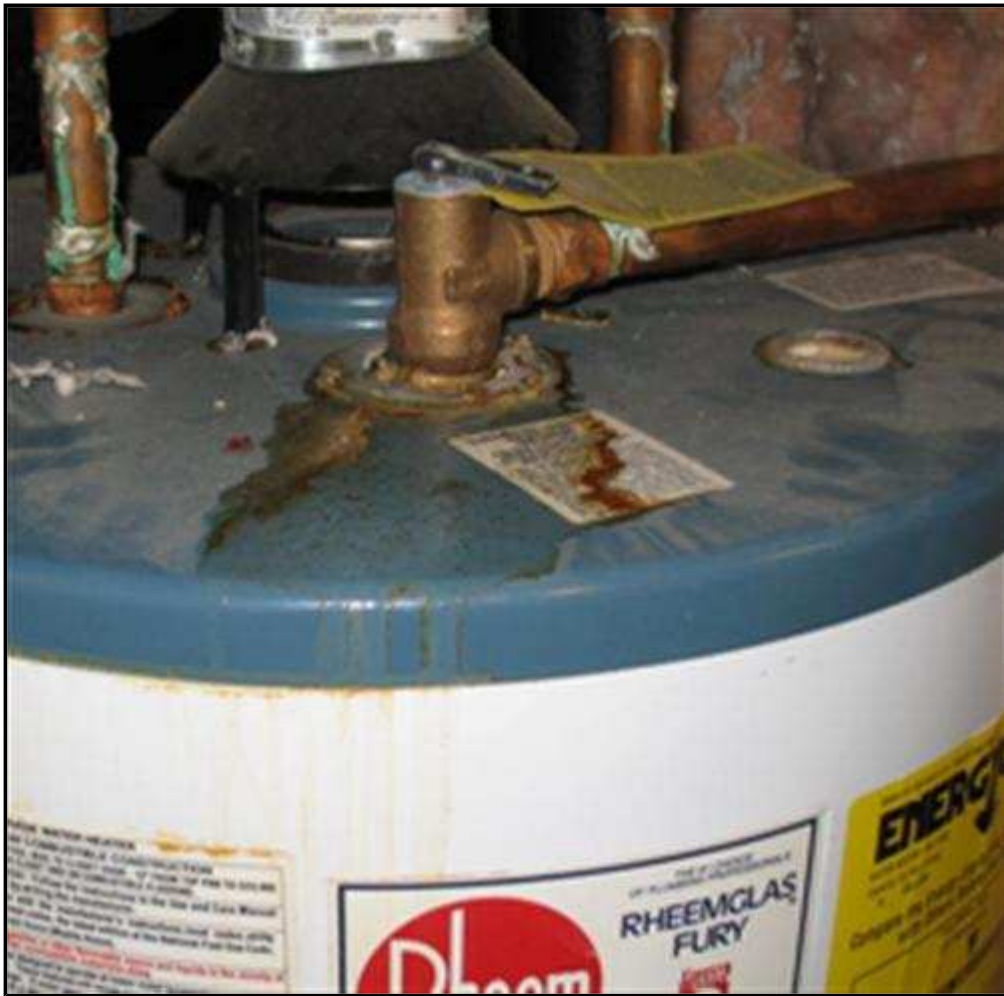
Item 9 - Picture 1

- (2) The water heater located in attic access off second floor office appears to be leaking at top of unit. A replacement is needed. I recommend a qualified professional inspect further and repair as necessary.

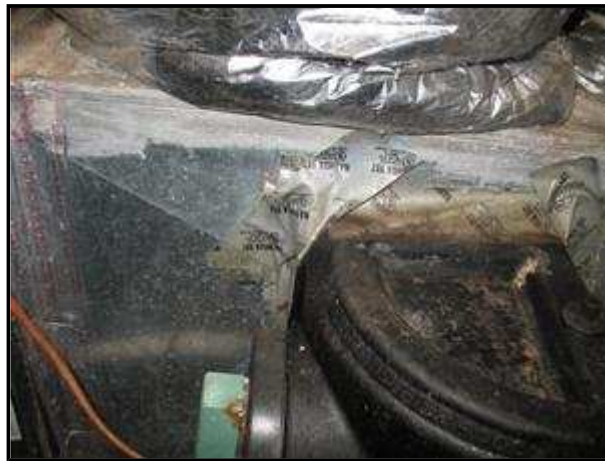
Item 13 - Picture 1 loose tape

- (1) The humidifier connection to basement furnace is loose.(Picture 1)

14. (2) These conditions can adversely affect overall system efficiency. I recommend a qualified professional to assess and make needed repairs.

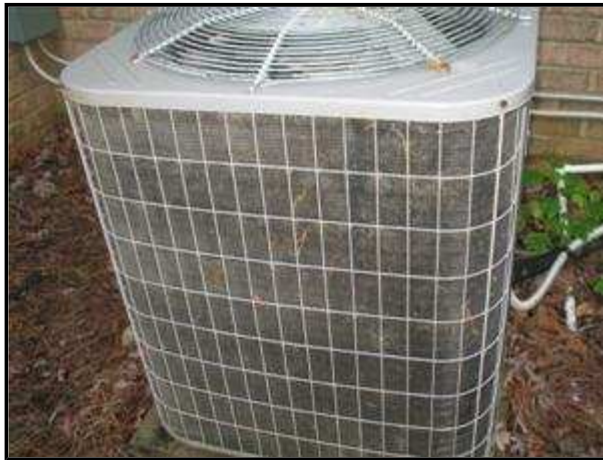
Item 16 - Picture 1 dirty coils

(3) Oxidation and dirt and debris has accumulated on outside AC unit. Dirty coils can affect overall system efficiency.Recommend cleaning coils by qualified individual.(Picture 1)

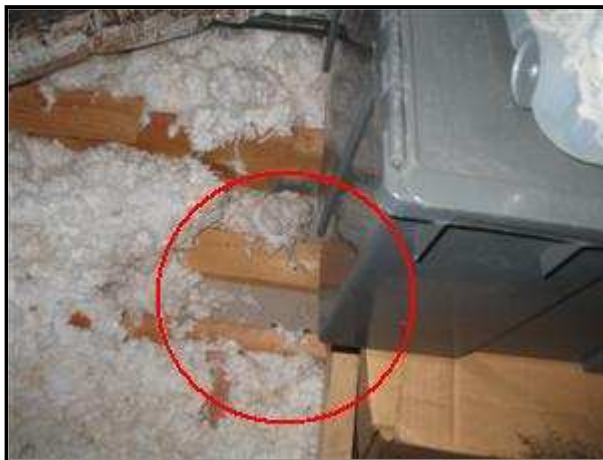
Item 17 - Picture 1

Fiberglass (loose-fill) insulation is Missing or pushed back in attic. even relatively small areas of missing insulation can result in considerable heat loss. A qualified person should repair or replace as needed.

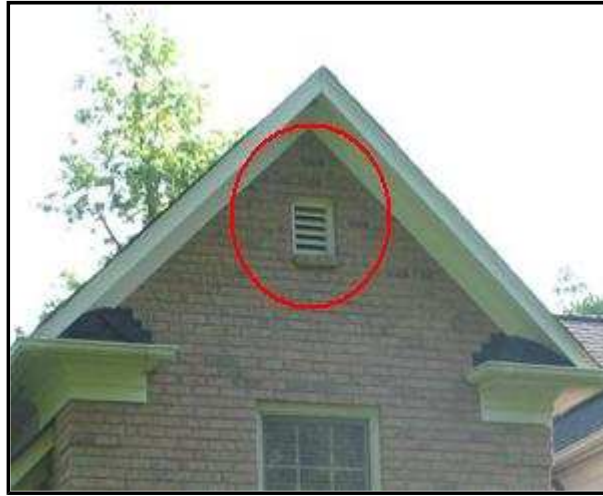
Item 19 - Picture 1

Vent Screening is missing on front of home (attic) allowing insects and/or animals entry. I recommend screening to be replaced.
